A Red Light Running (RLR) Photo Enforcement System was installed at the intersection of US Rte. 6 (159th Street) at Crawford Avenue on October 20, 2014 (westbound), after finding limited success with other attempted measures to promote safer driving and improve compliance with traffic laws. As a condition of use, both Illinois law and the Illinois Department of Transportation require periodic statistical analyses/evaluations be conducted.

US Rte. 6 (159th Street) at Crawford Avenue
Markham, IL

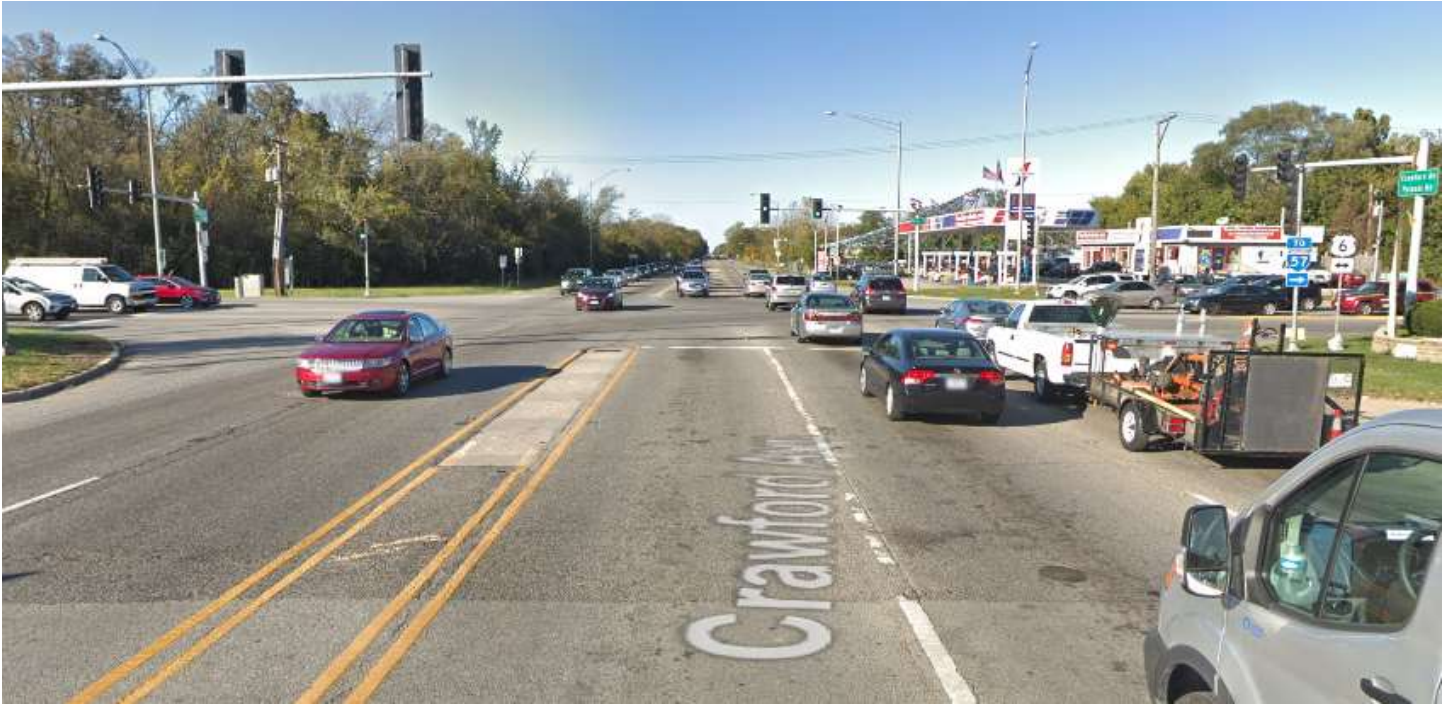
US Rte. 6 (159th Street) at Crawford Avenue, Northbound Approach

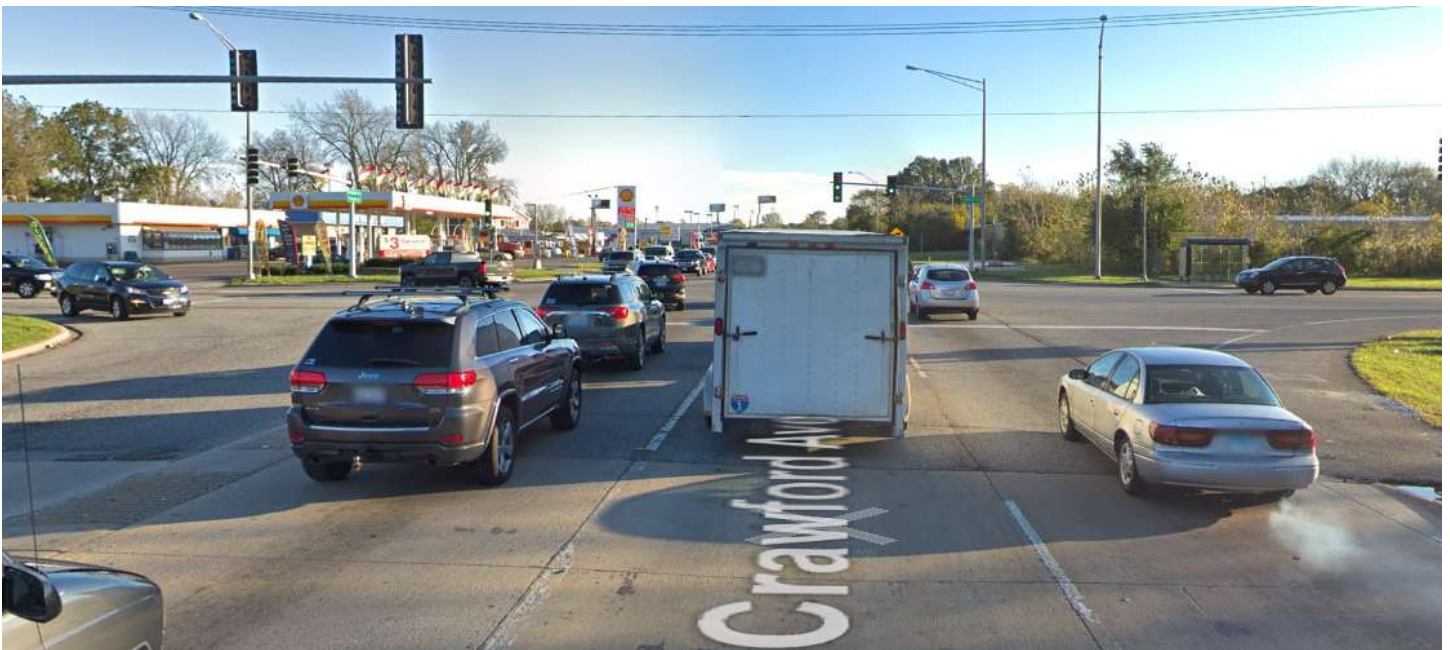
US Rte. 6 (159th Street) at Crawford Avenue, Southbound Approach

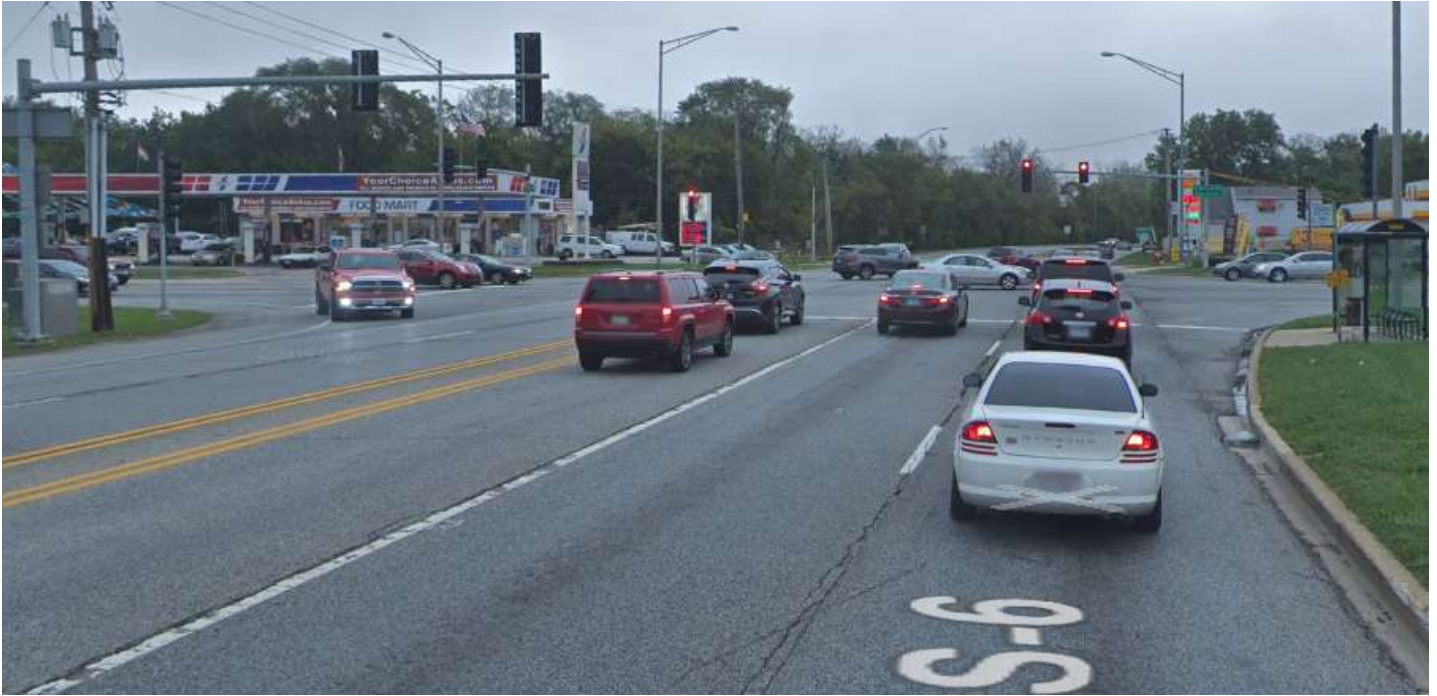
US Rte. 6 (159th Street) at Crawford Avenue, Eastbound Approach

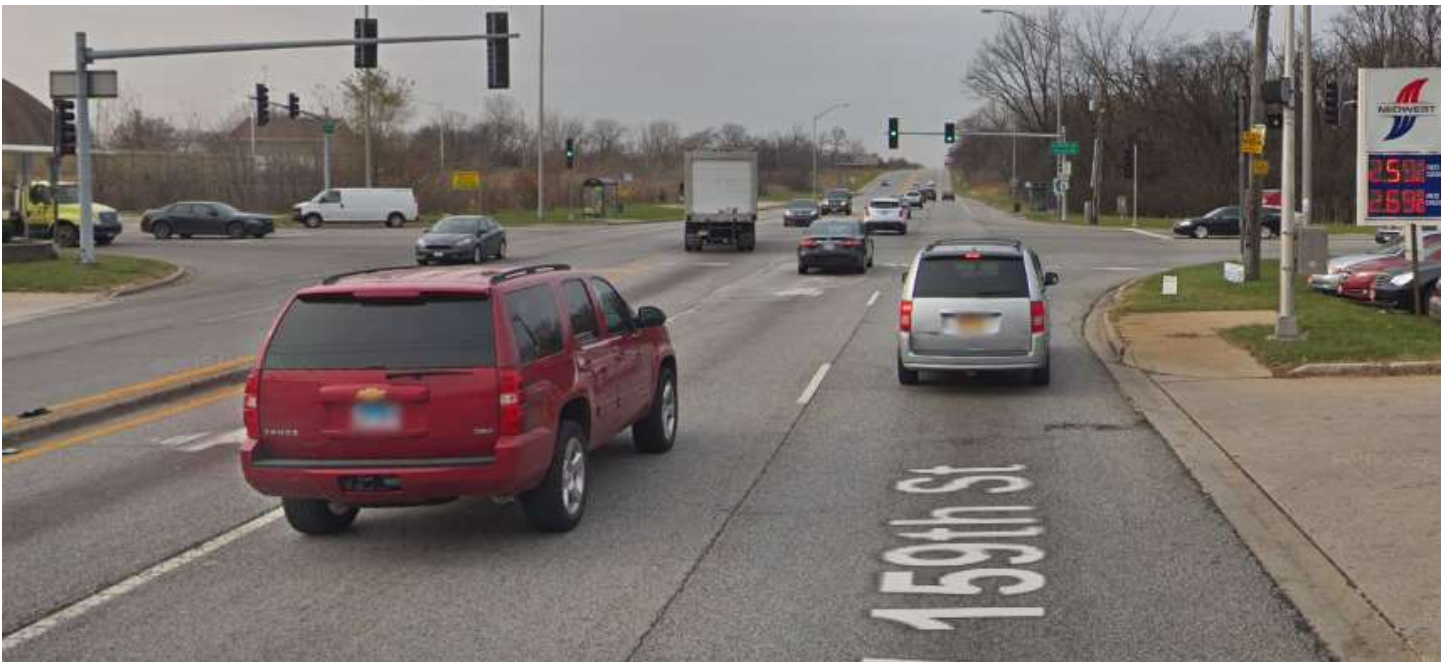
US Rte. 6 (159th Street) at Crawford Avenue, Westbound Approach
